Description: MD-Wall and Real-Wall Radar Cross-Section Analysis  
Test venue: Upper Heyford, Oxfordshire  
Date of test: 7<sup>th</sup> May 2019

## 1. General background

## 3. The construction and test

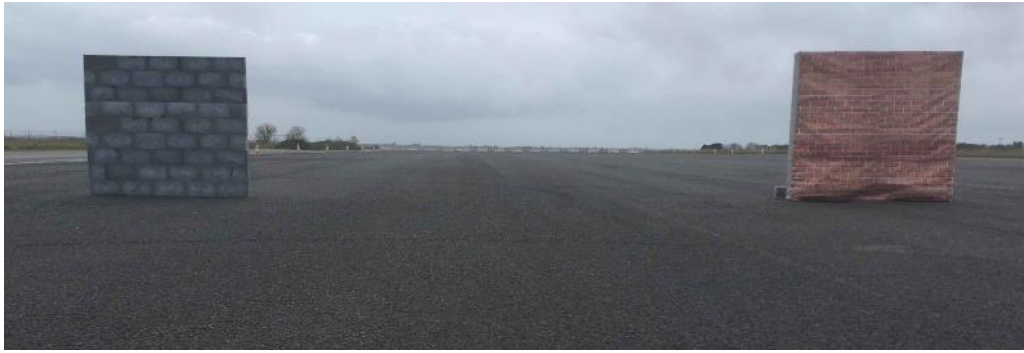
*Image shows both MD-Wall and Real wall. The real wall was the exact location of the test, MD-Wall moved to this location.*

It was felt that the best way to conduct a comparison was to construct a real 2 m x 2.2 m wall on a precise known location, taking radar reflectivity measurements, then tearing it down and replacing with one of our newly constructed 2 m x 2.2 m soft walls in exactly the same location and repeating the same tests.

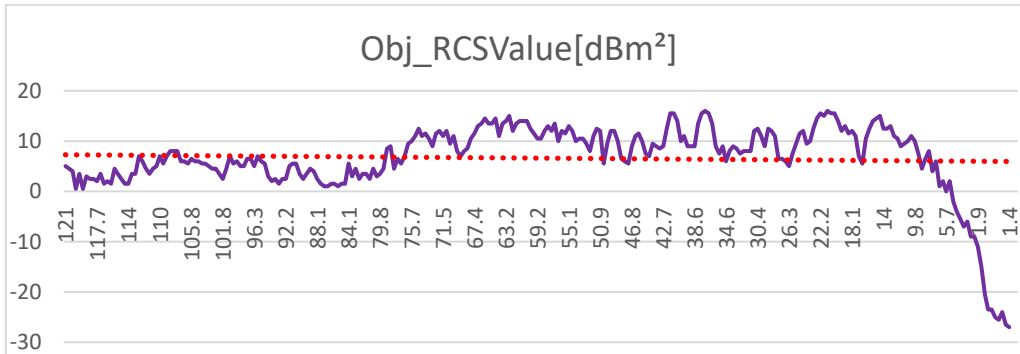
Real-block wall

RCS average linear approach: 6.61 dBm<sup>2</sup>  
 RCS average 30 sec static at 30 m: 9.36 dBm<sup>2</sup>

**Comments:** It is noted that the foam wall by default already has a much greater radar signature than the equivalent sized wall made of real brick blocks.

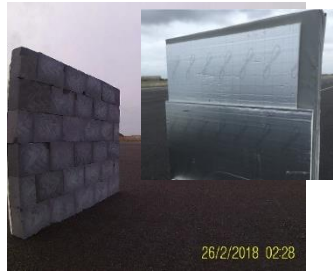
Real wall with foil lining

RCS average linear approach: 19.63 dBm<sup>2</sup>

RCS average 30 sec static at 30 m: 17.31 dBm<sup>2</sup>

**Comments:** Adding foil significantly increases the signature of both walls. It does make more of a difference to the Real wall bringing it to approximately the same value as the MD-Wall **without** a foil lining.

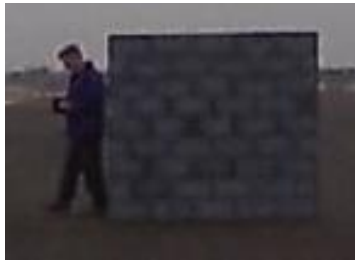
Real wall with pedestrian completely behind during test

Linear approach tests invalid

RCS average 30 sec static at 30 m: 4.04 dBm<sup>2</sup> –

*(it is noted that the average is 9.83 dBm<sup>2</sup> two thirds into dataset and levels out)*

**Comments:** The linear test result was invalid on the real wall run. But the static test reads much lower than expected value – it appears to jump back up to an expected value two thirds into the data set. This test is therefore invalid, but we can conclude that the real wall. Is ‘most likely’ higher by approximately 3 dBm<sup>2</sup> with a pedestrian behind when compared to a wall without pedestrian. The MD-Wall appears to block the pedestrian from view as the value is approximately the same with or without the pedestrian. This is good news as it successfully obscures the pedestrian!

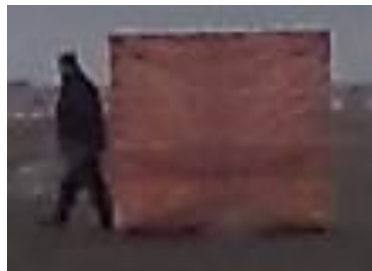
MD-wall with pedestrian completely behind during test

RCS average linear approach: 19.64 dBm<sup>2</sup>

RCS average 30 sec static at 30 m: 20.58 dBm<sup>2</sup>

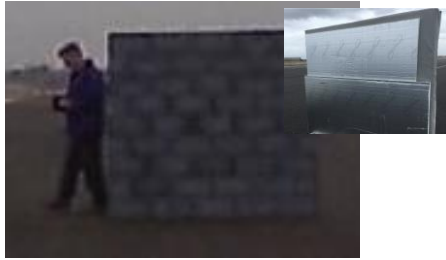
#### 4.4. Test 4 - Real v Soft + Reflective film + Pedestrian behind

Real wall + Foil lining with pedestrian completely behind during test

Test not done – top layer of brick collapsed before it could be tested with a pedestrian.

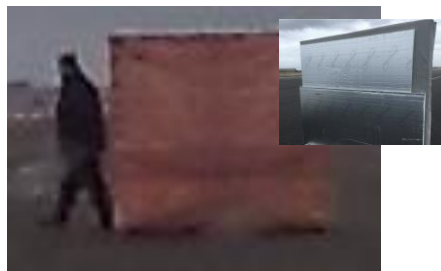
MD-Wall + Foil lining with pedestrian completely behind during test

RCS average linear approach: **27.43 dBm<sup>2</sup>**  
RCS average 30 sec static at 40 m: **28.03 dBm<sup>2</sup>**  
(The 30 m static run was invalid)

The MD-Wall behaves consistently once again and shows higher value consistent with test 2 and no variance with a pedestrian behind. Again, very good news!

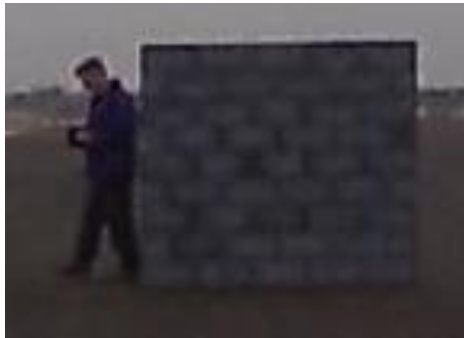
Real Wall – walkout at 30 seconds

RCS average 60 sec static at 30 m: 8.23 dBm2

RCS average 60 sec static at 40 m: 15.43 dBm2

**Comments:** Some evidence of unspecific data change following the pedestrian emerging at 30 s into the data set. There are two blips of data change following the pedestrian emergence but little else. The Pedestrian walking away clearly has an effect which is to be expected, but nothing at all while behind.

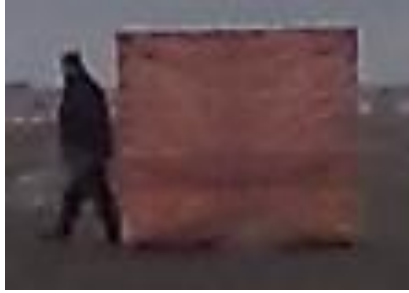
MD-Wall – walkout at 30 seconds

RCS average 60 sec static at 30 m: 20.58 dBm2

RCS average 60 sec static at 50 m: 22.81 dBm2

**Comments:** No evidence of change in either. Would have expected some blip in the data as before but no change here.

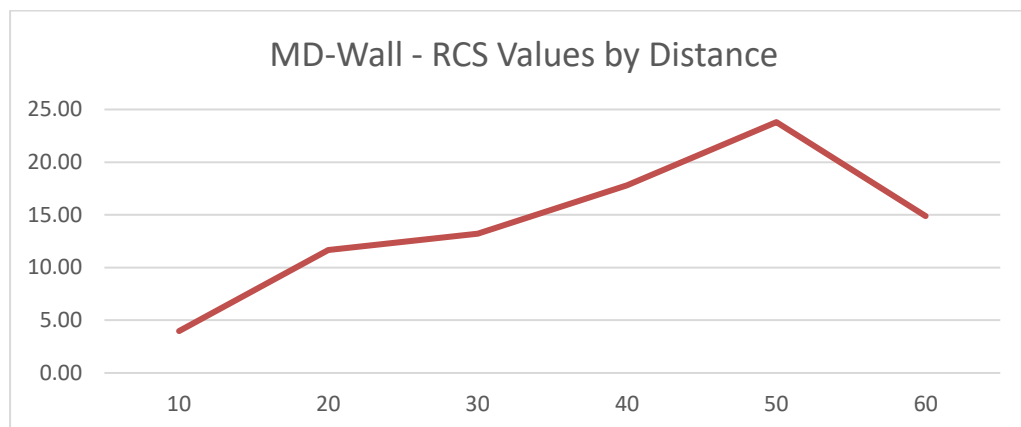
Graph below shows a plot of the MD-Wall total RCS averaged data plotted by distance.
